TO : OUR VALUED DISTRIBUTORS
FROM: Alex Tsen –Fall Protection Project Manager
DATE: September 3, 2008
SUBJECT: FP541 Rope Grab Clinch Nut Product Advisory

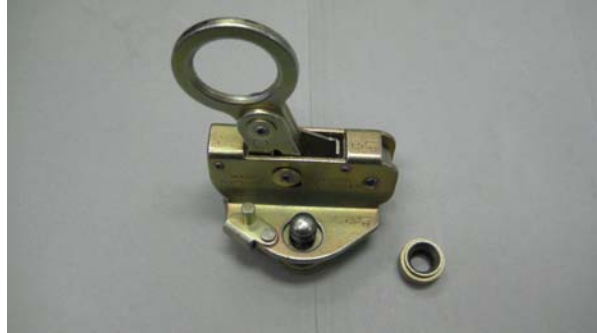
Figure 3

While a rope grab will continue to function as intended until the cinch nut is dislodged completely from the unit (Figure 3), we recommend that in an abundance of caution, you remove any rope grab from service that begins to demonstrate a separation between the thumb screw and cinch nut. (Figure 2).
